**Crofton Hills HOA**  
**Covington, WA**

Report #: 48914-0  
Beginning: January 1, 2025  
Expires: December 31, 2025

**RESERVE STUDY**  
**"Full"**

January 15, 2024

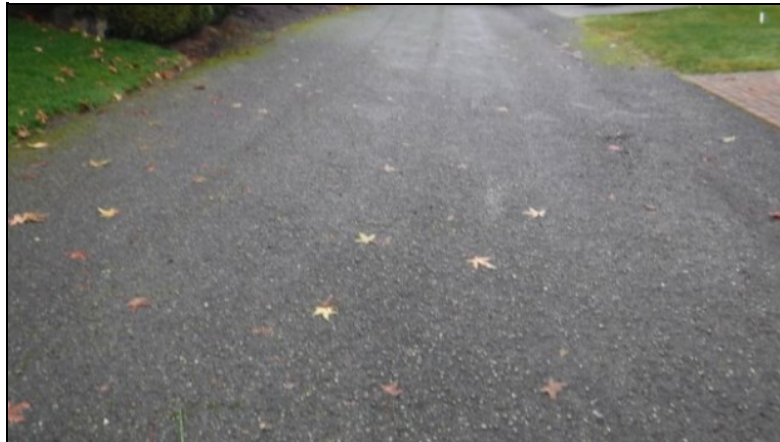
Comments: Plat map notes (9, 10, 17, 18, 19) for the driveway alleys identify these areas as ingress, egress and utilities tracts which serve specific lots served by the tracts and note these areas are dedicated and conveyed an equal and undivided ownership interest to those owners. It also notes these owners shall be responsible for the maintenance of said tracts. With this understanding, no reserve funding included here. We noted most of the asphalt at these tracts has significant raveling, some edge deterioration and moss.

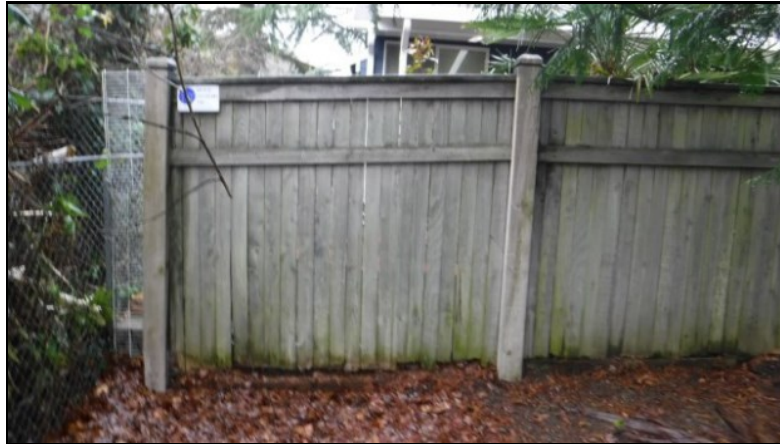
**Comp #: 138 SE 256th St. Fence - Repr/Replace**

Comments: Our board contact reports this fence is the responsibility of the Association to maintain, repair and replace.

Declaration Section 5.4.7, does elude to Board having that authority. This wood board fence has pressure treated 6" posts with 4" boards. Boards and other lumber are tight knot cedar as specified by declaration. While no obvious widespread instability noted, there was rot and green mildew at base of boards as in contact with ground. It does not appear fence has been routinely stained.

Plan to replace the fence at roughly the time frame below. Typical failures occur from deterioration through the end grains, and contact with the ground and surrounding landscape.

As routine maintenance, inspect regularly for any damage, and repair as needed. Avoid unnecessary contact with the ground, sprinkler patterns, and surrounding vegetation. Regular cycles of stain/paint will help to maintain appearance. Painting or staining the fence has a higher overall life cycle cost, but may extend life in addition to an aesthetic benefit.

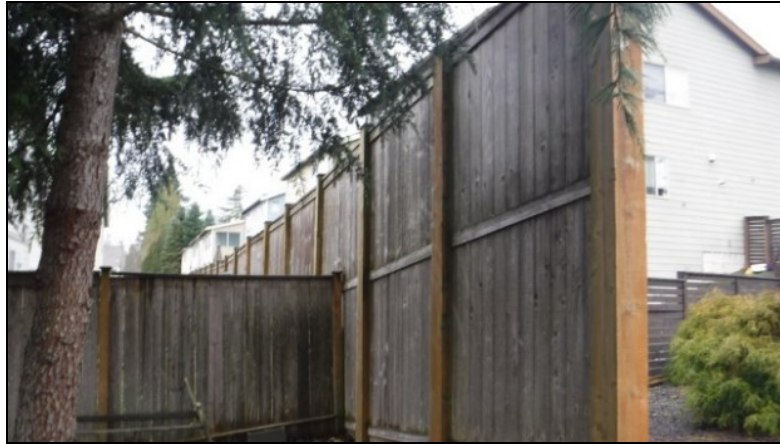
Comments: According to the Declaration Section 1.5.5, the perimeter fence along the northern boundary of the project adjoining Tracts K and L & Lots 37-43 is considered common area. This fence is wood board fence with pressure treated 8" posts with 6" boards. Boards and other lumber are tight knot cedar as specified by declaration. We only viewed very small amount as landlocked fencing. We noted older appearance, however no obvious instability noted. It does not appear fence has been routinely stained.

Plan to replace the fence at roughly the time frame below. Typical failures occur from deterioration through the end grains, and contact with the ground and surrounding landscape.

As routine maintenance, inspect regularly for any damage, and repair as needed. Avoid unnecessary contact with the ground, sprinkler patterns, and surrounding vegetation. Regular cycles of stain/paint will help to maintain appearance. Painting or staining the fence has a higher overall life cycle cost, but may extend life in addition to an aesthetic benefit.

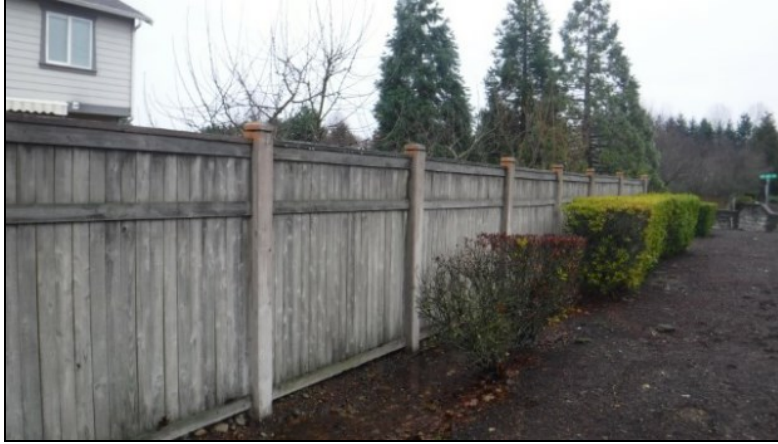
**Comp #: 142 Wood Fencing - Clean & Stain**

Funded?: No. Current older fence has not routinely been stained

Comments: Fencing has not been routinely stained. We recommend, once fencing is replaced, a routine staining cycle be implemented. Regular sealer applications are recommended for the appearance, protection, and maximum useful life of the wood. Actual timing of staining will vary based on exposure, and quality of material and application. In our experience, quality solid-bodied stain typically produces the best result. Remove any unnecessary contact with the ground, surrounding landscape, and sprinkler patterns. Repair as needed, and clean prior to sealer application.

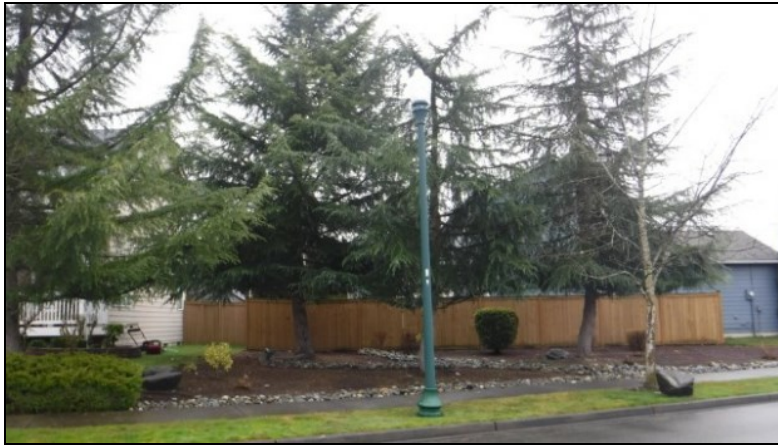
**Comp #: 160 Street Lights - Repair/Replace**

Comments: Street lights throughout community have IntoLight tags and assumed responsibility of utility company to maintain, repair and replace.

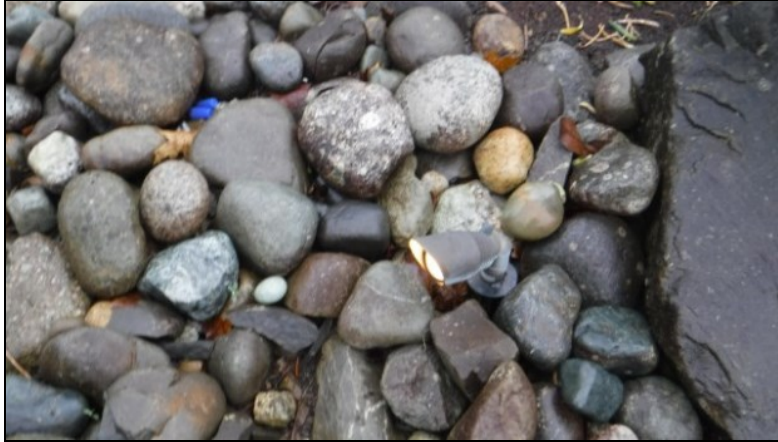
**Comp #: 165 Grounds Lights - Repair/Replace**

With only two small lights, assumption is can be repaired/replaced when needed out of the operating budget with no predictable basis for large scale reserve funding. As routine maintenance, inspect, and repair/change bulbs, as needed.

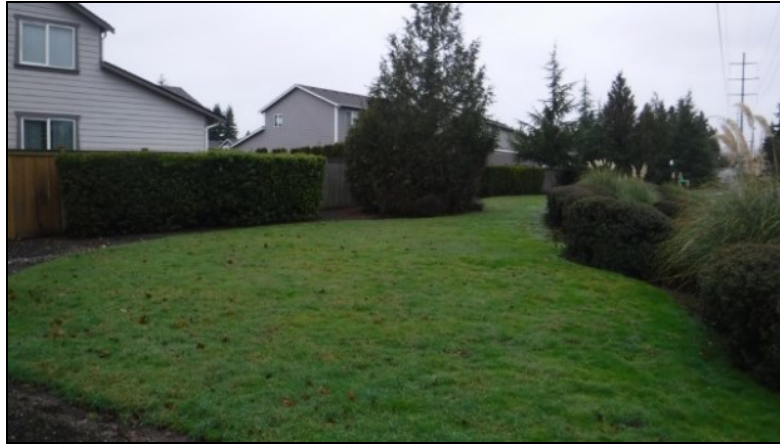
While landscape maintenance is currently funded through the operating budget, as the plantings continue to age, the need or desire for large-scale refurbishment projects not covered within the maintenance contract will arise. These types of projects can include bed renovations, major replanting, large-scale bark or mulch replacements, turf renovations, drainage improvements, irrigation system extensions/replacement, etc. A budget allowance included here for these larger refurbishment projects that will exceed typical operating budget, maintenance funding. Walk the landscaped areas each year with the community's landscape contractor, and perhaps a landscape architect, to assess the overall health, function, and adjust this component as needed. Again, the timing/costs here are a budget allowance.

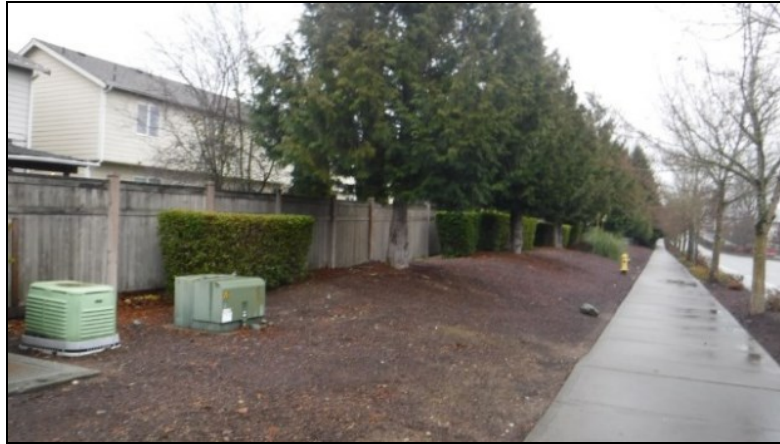
**Comp #: 171 Trees - Trim/Remove/Replace**

Comments: There are street trees planted in the landscape strips separating the sidewalk from the roadway and located in the Right of Way. General Notes #4 on the plat map states maintenance of these areas shall be the responsibility of the HOA, however, the Declaration Article 5.4.6 states the Lot Owner at the Owner's expense (rather than the Association) shall maintain and landscape such areas adjacent to such Owner's Lot if governmental agency fails to do so. There was at least one instance in which the city trimmed some trees in the planter strip adjacent to homeowner lot, but this was in response to citizen concerns that signs were obstructed and it is not regular practice in these areas for city.

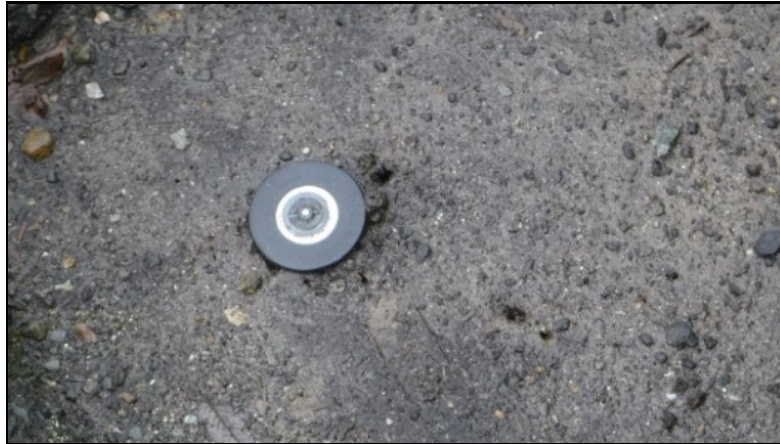
**Comp #: 173 Irrigation System - Repair/Replace**

There are no predictable large-scale costs at this time. Have your landscaper or irrigation specialist periodically unearth sections to check lines for any damage or deterioration. PVC can eventually become brittle and leak (typically not before the 40 year mark of life).

As routine maintenance, inspect, test, and repair the system, as needed, as part of the operating budget. Follow proper winterization and spring startup procedures. If properly installed and bedded without defect, the lines could last for many years. Controls for the system can vary greatly in number, cost, and life expectancy - typically each controller is less than \$500. Other elements (i.e. sprinkler heads, valves) within this system are generally lower cost, and have a failure rate that is difficult to predict. These elements are better suited to be handled with operating funds, not reserves.
