Crofton Hills HOA
Covington, WA

Report #: 48914-0
Beginning: January 1, 2025
Expires: December 31, 2025

RESERVE STUDY
"Full"

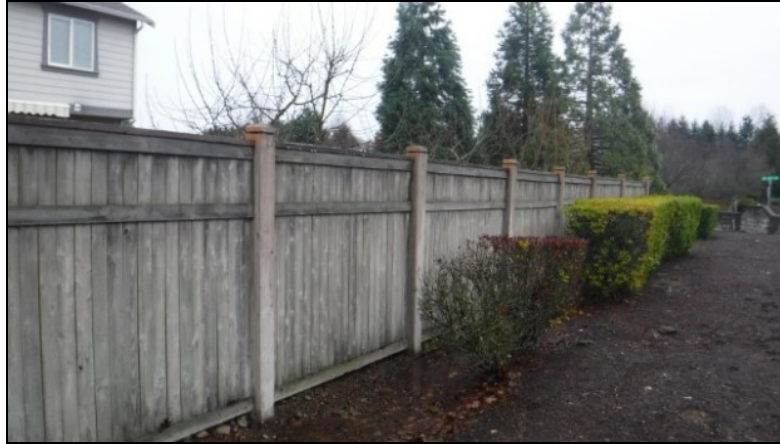
Comp #: 142 Wood Fencing - Clean & Stain

Funded?: No. Current older fence has not routinely been stained

Comments: Fencing has not been routinely stained. We recommend, once fencing is replaced, a routine staining cycle be implemented. Regular sealer applications are recommended for the appearance, protection, and maximum useful life of the wood. Actual timing of staining will vary based on exposure, and quality of material and application. In our experience, quality solid-bodied stain typically produces the best result. Remove any unnecessary contact with the ground, surrounding landscape, and sprinkler patterns. Repair as needed, and clean prior to sealer application.

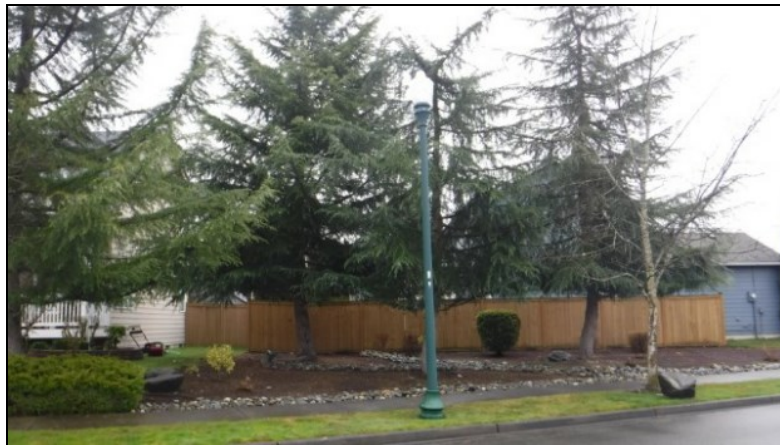
Comp #: 160 Street Lights - Repair/Replace

Comments: Street lights throughout community have IntoLight tags and assumed responsibility of utility company to maintain, repair and replace.

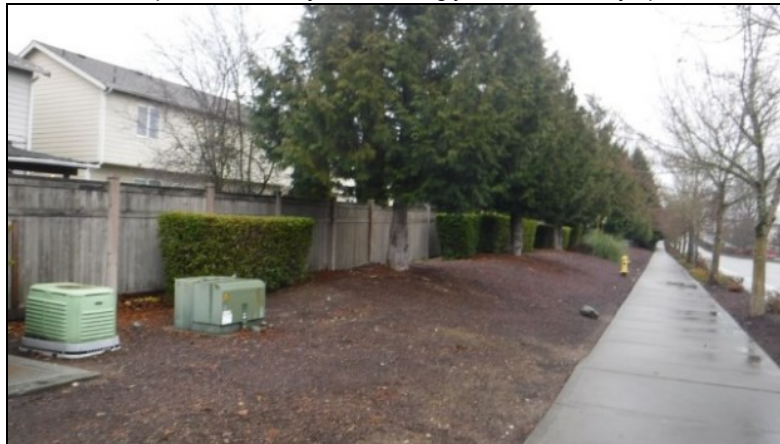
Comp #: 171 Trees - Trim/Remove/Replace

Comments: There are street trees planted in the landscape strips separating the sidewalk from the roadway and located in the Right of Way. General Notes #4 on the plat map states maintenance of these areas shall be the responsibility of the HOA, however, the Declaration Article 5.4.6 states the Lot Owner at the Owner's expense (rather than the Association) shall maintain and landscape such areas adjacent to such Owner's Lot if governmental agency fails to do so. There was at least one instance in which the city trimmed some trees in the planter strip adjacent to homeowner lot, but this was in response to citizen concerns that signs were obstructed and it is not regular practice in these areas for city.

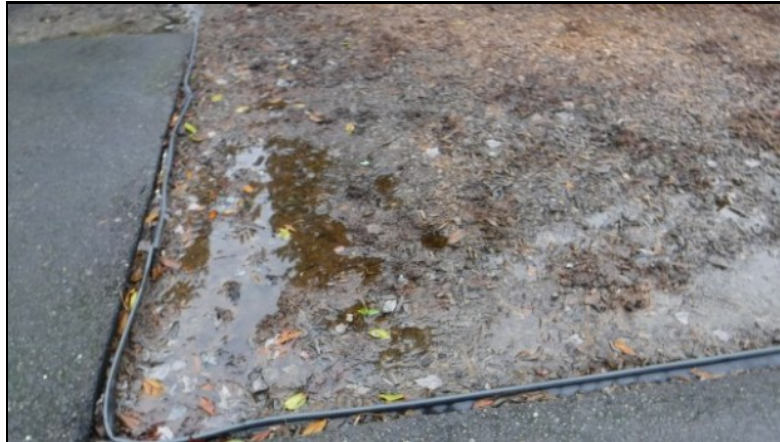
Funded?: No. There is no predictable large-scale repair/replacement at this time, Association not responsible.

Comments: There is very little drainage systems known to be the responsibility of the Association. Roads are public and Driveway/alley (#121) are not Association responsibility. As we observed and discussed with board member, poor drainage at park area play structure beds (see photo). No analysis at this time and no basis for cost. Board member reports, this will be looked into prior to park equipment replacement.

There is no predictable large-scale repair/replacement at this time. Local repairs should be performed as part of general maintenance.

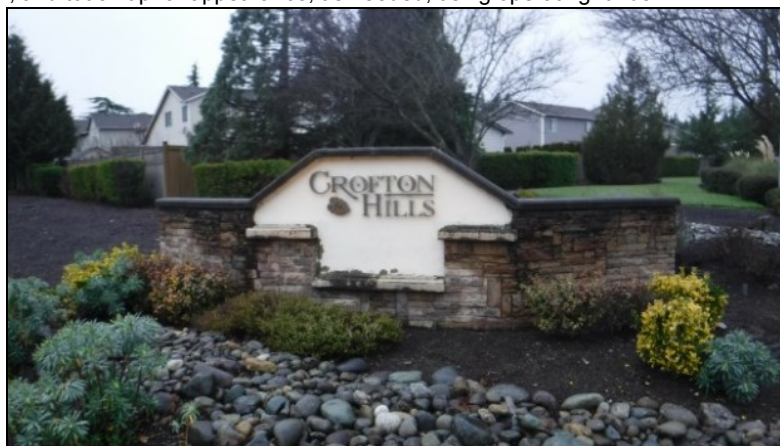
Comp #: 190 Monument/Sign - Repair/Replace

Comments: Monument wall with attached lettering in stable condition, however areas of dirt/grime and peeling paint. Reported to be original and repainted in the past.

Reserves funding is recommended for regular intervals of replacement to maintain a consistent and quality appearance.

Inspect periodically, repair, clean, and touch up for appearance, as needed, using operating funds.

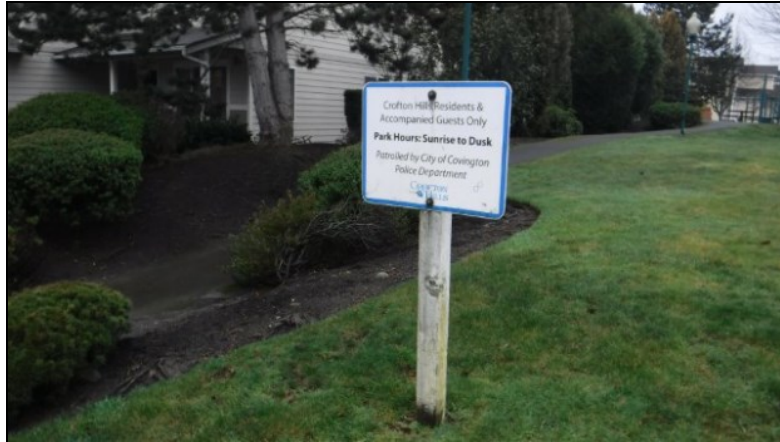
Comp #: 191 Signs – Repair/Replace

Comments: There are some small signs within the community park. Assumption is can be repaired/replaced individually when needed as does not meet typical reserve fund threshold.

Reserves funding is recommended for regular intervals of replacement to maintain a consistent and quality appearance.
